FINAL REPORT

Spring Mission: March 20, 2012 – April 25, 2012

“Conservation and Documentation of the Wall Paintings at the Red Monastery, Sohag”

Sub-grant No. EAC-34-2012

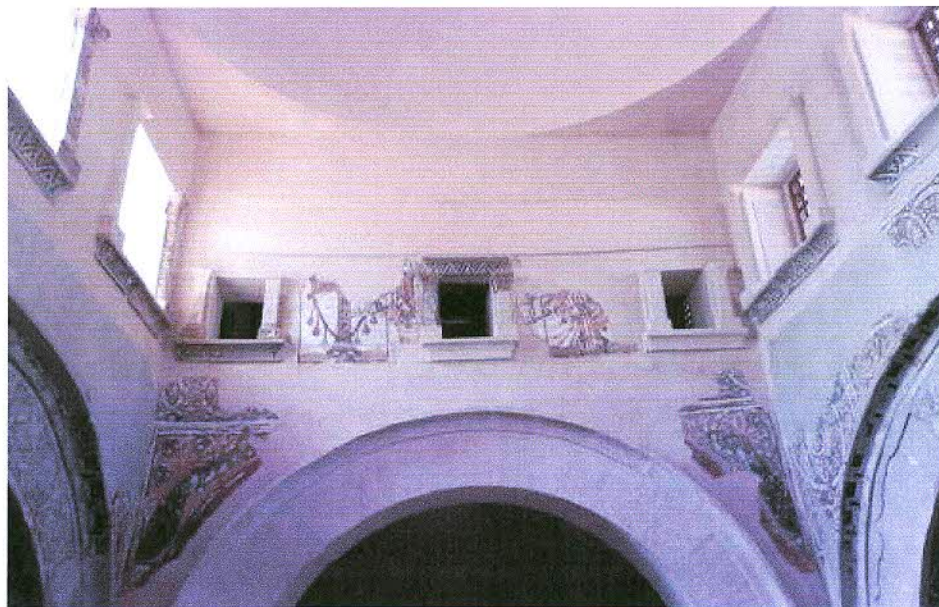
(Figure 1)

The conservation campaign conducted in the Monastery of St Bishoi (Red Monastery) at Sohag¹ during the spring of 2012 involved the following parts of the building: the central dome and the four horizontal pendentives built by the Comité, the central window on the west wall of the clerestory and the stone entrance arch to the Sanctuary. On the same wall, the paintings of the two peacocks flanking the arch were also completed (Figure 1).

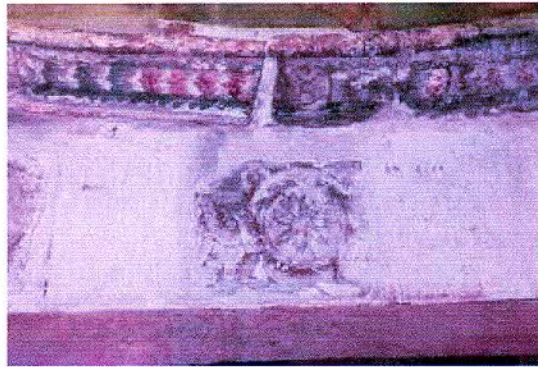
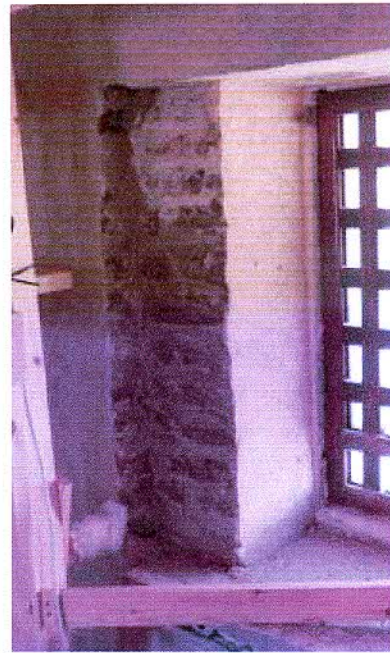
(Figures 2 and 3)

The triconch is built of blocks of limestone from local quarries, infilled with fired bricks. The niches in the lowest tier are built of fired bricks measuring approximately 19 x 9 x 11 cm, arranged horizontally lengthways. The moldings and semi-capitals are made of limestone. The string courses separating the tiers are also made of limestone (Figure 2).

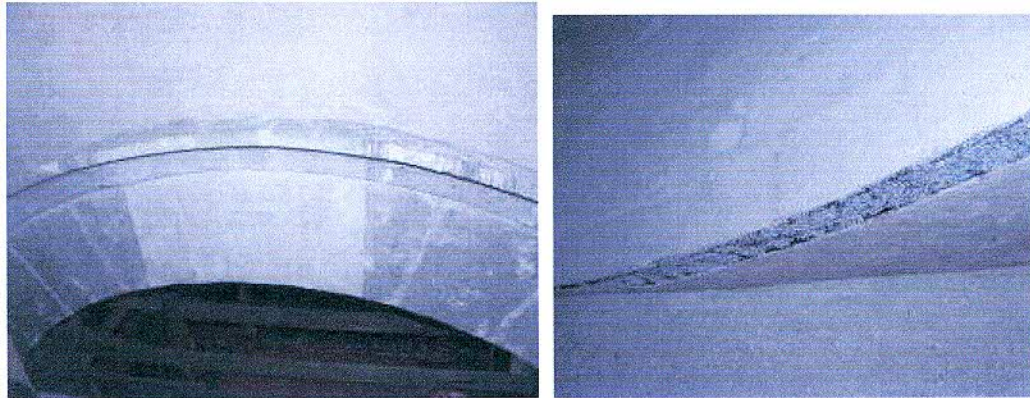
(Figures 4 and 5)

The central dome restored by the Comité is built of perforated bricks laid on an iron ring (Figure 5) that functions as a base and rests on the top of the clerestory some 80 cm above the windows. Perforated bricks were used because the structure had to be light. The entire

upper part of the clerestory was rebuilt by the Comité using fired bricks bedded in lime mortar (Figure 3).

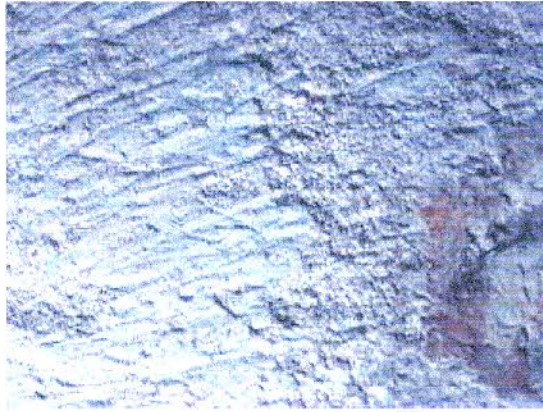
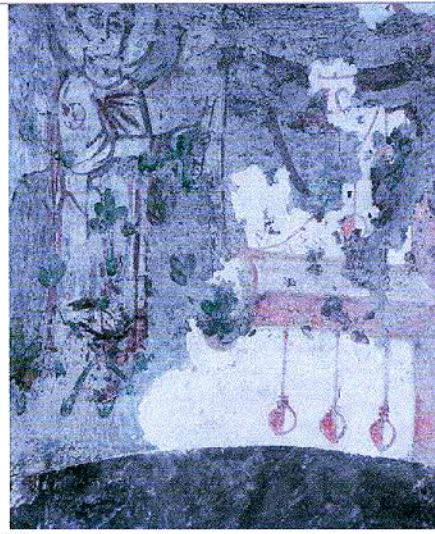
(Figures 6 and 7)

In the niches of the lowest tier of the east lobe the palimpsest comprises three levels: the oldest, that has proved impossible to examine in the areas restored, has been identified as the first phase of painting in the triconch. It is uniform with a fine white wash [*covering*] the surface of the stone and the masonry (Figure 6).

This first thin layer is covered by the second-phase plaster. This was applied in a layer approximately $\frac{1}{2}$ to 1 cm thick and is lime-based with inclusions in the form of smooth round grains of sand. It has a white surface finish (Figure 6). Here the second-phase plaster has a much smoother surface than it does in the upper tiers. This plaster is covered by the third and final late-antique phase with its trademark white wash.

In the central niche that has been partially restored to half its height, three phases are visible. The two latest (more recent) are in the form of painted washes covering the second phase. Whilst in the two lateral niches the second-phase plaster is only covered by a third-phase wash, in the central niche, there is also a later white wash possibly applied during the medieval period (Figure 7).

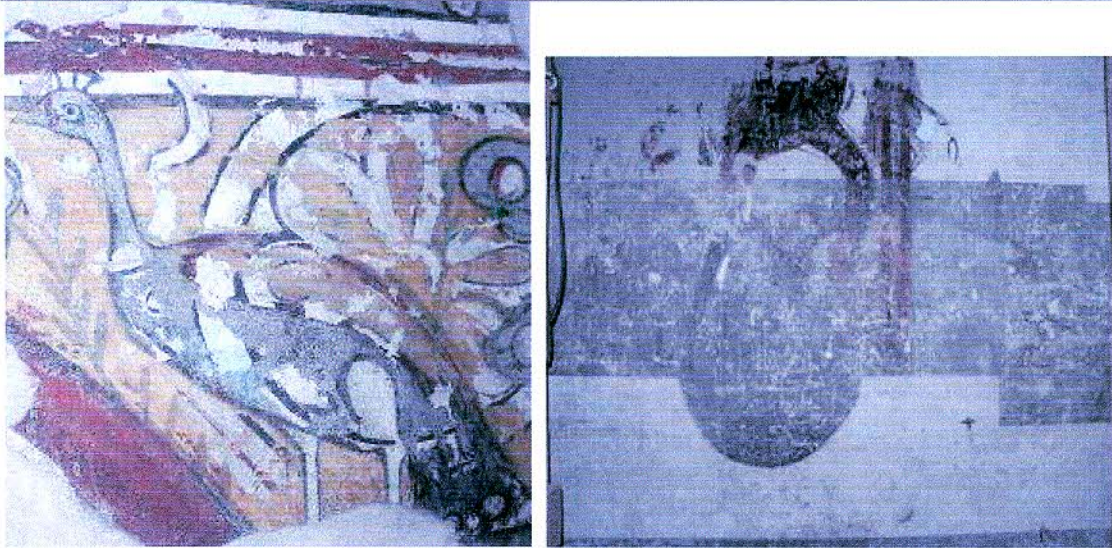
(Figures 8 and 9)

In the facade area (F-north wall) the plaster is medieval, applied when the external walls were rebuilt. This plaster, contemporary with the monochrome painting of the cross on the left side (now interrupted by the wall built by the Comité that leans against it), as already described in the autumn 2011 report, comprises lime and sand with a good deal of straw in the mix (Figure 9). The same plaster is also present on the north side of the north corridor. On the west side of the clerestory, like the other three sides that have already been restored, third-phase white wash overlies the second-phase plaster (Figure 8).

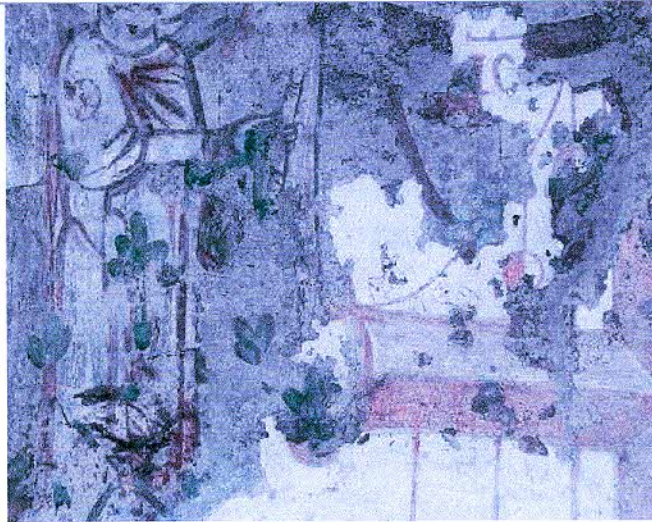
(Figure 10)

Cleaning of the central niche in the lowest tier of the east lobe revealed a new palimpsest with a later phase overlying the layers of late antique plaster. The oldest painted plaster, visible only in limited areas, depicts *velaria* and floral patterns painted using the encaustic technique typical of the second phase. This is extremely significant because it shows that during the second phase of late antique painting, the niches of the east lobe were only decorated with painted *velaria*⁴ and not representations of human beings (Figure 10).

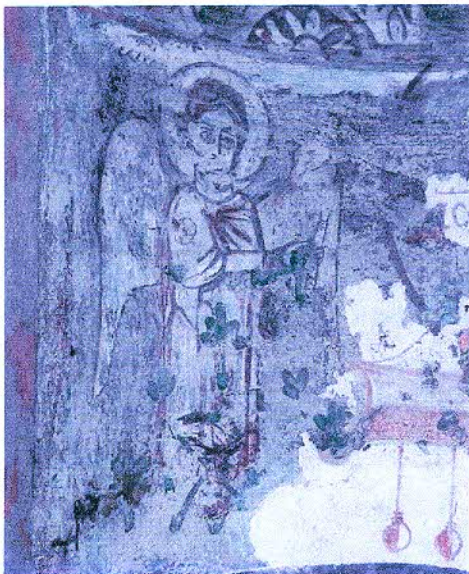
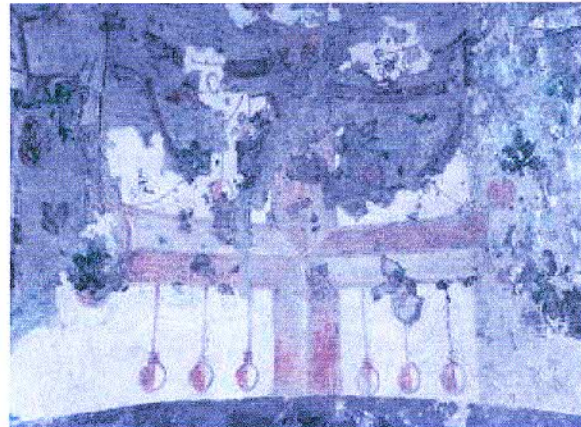
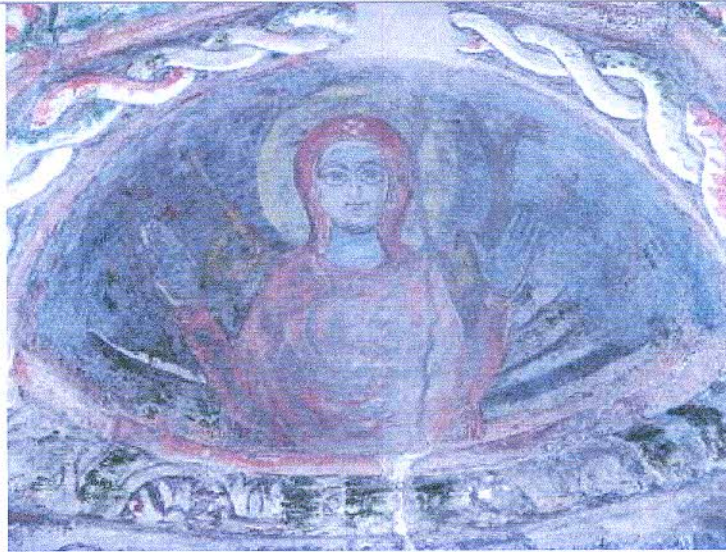
(Figures 11, 12 and 13)

This plaster is overlaid by the succeeding phase in the form of white wash. The quality of the white wash suggests the third phase but the poor state of preservation makes it difficult to state this with certainty. The surviving fragments allowed us to identify an angel holding a scroll, facing the central *clipeus* that may originally have contained a cross, now lost. The artist has used a very restrained palette and the composition is extremely graphic with some lines in red earth (Figure 11). The small Madonna depicted in the upper part of the niche must also belong to this phase (Figure 13).

In the central part of the niche this white wash is overlaid by a second layer of white on which a cross is depicted using only red earth. What appear to be six ostrich eggs are hanging from the horizontal arms of the cross⁵ (Figure 12).

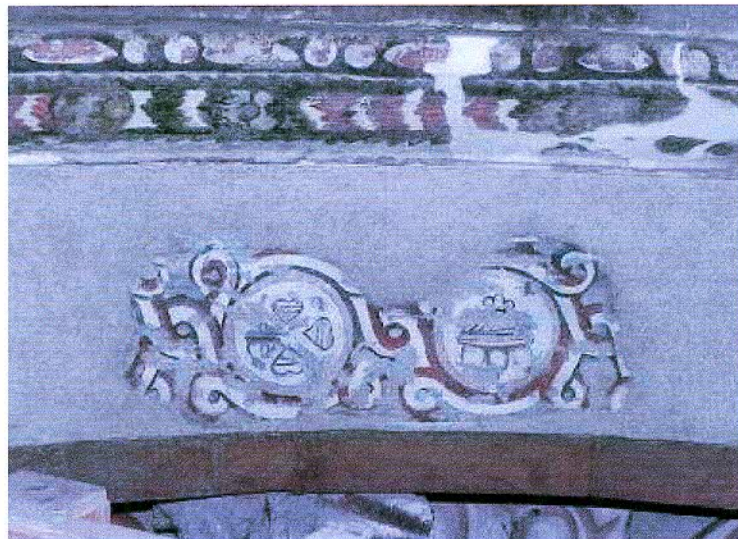
(Figure 14)

Ascending to the string course between the second tier and the apse in the same lobe, the third-phase painting once more explores a geometric theme in the form of a red and white band that furls and loops around a horizontal series of *clipei* (Figure 14). This decoration is not greatly dissimilar to that on the corresponding north and south string courses.

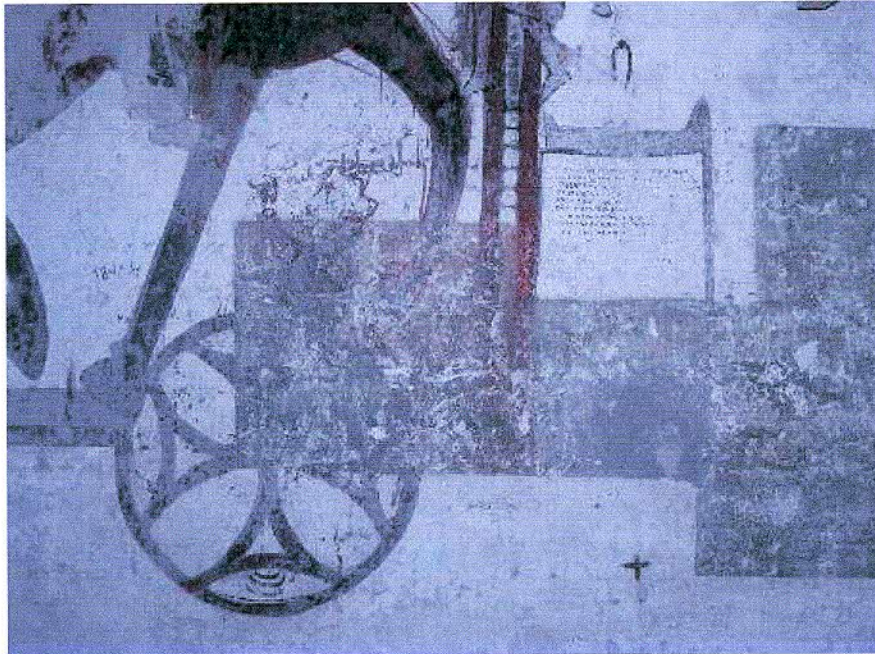
Figure 15

second soldier beneath the horse. A cross inscribed within a circular *clipeus* was also discovered at the same level as the abovementioned soldier (Figure 15).

Given the poor state of preservation it is difficult to say whether this precedes or succeeds the composition of the Saint on Horseback.

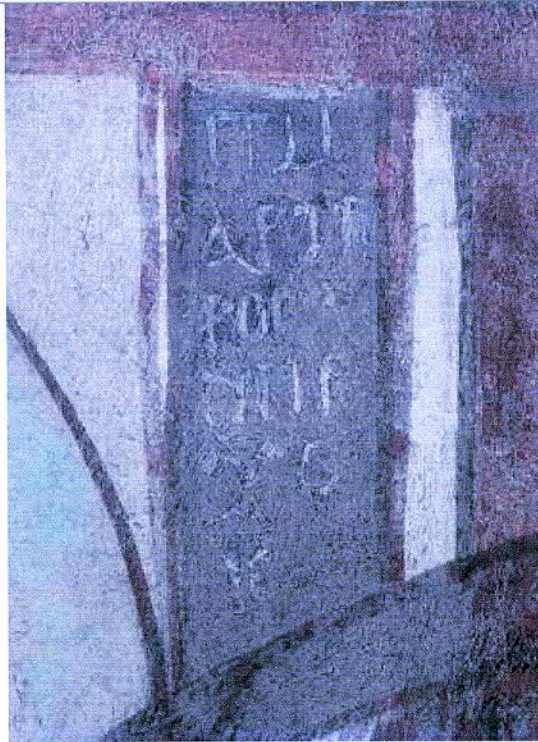
Figure 16

During the season, work was completed on the two inscriptions flanking the halo of the Saint on Horseback, confirming that white lead (that subsequently turned purple) was the white pigment used for many details in this scene. Unfortunately, only part of the inscription in the right-hand cartouche can be deciphered (Figure 16).

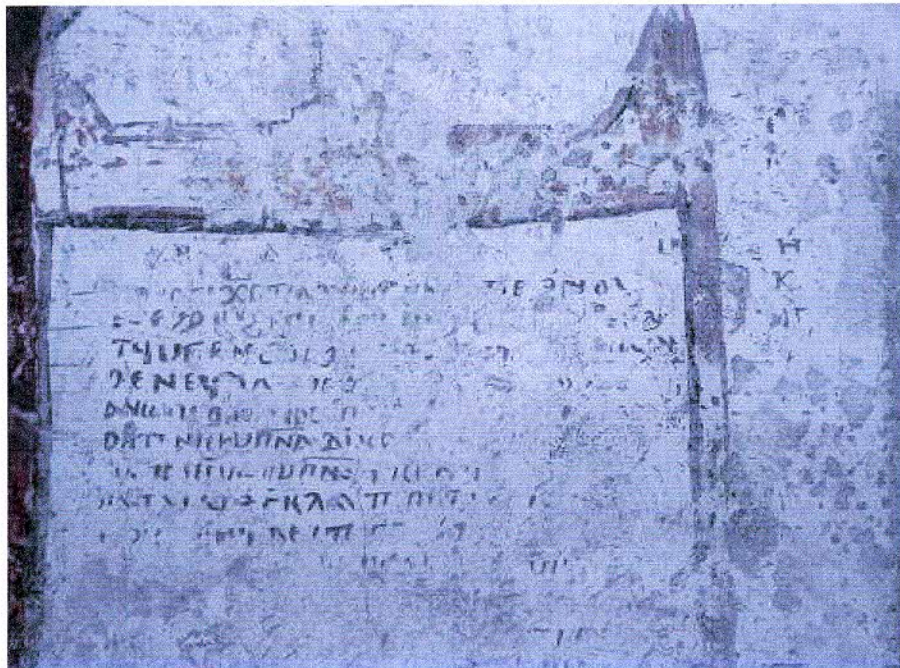
Figure 17

A Coptic inscription on the right-hand side was cleaned but proved to be extremely patchy (Figure 17).

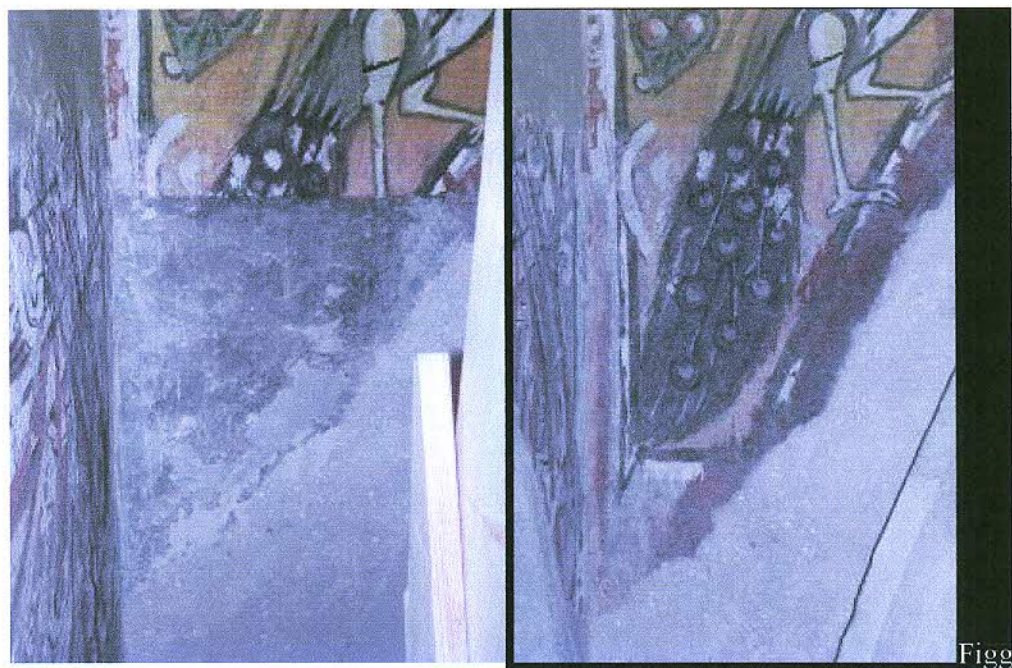
Figures 18 and 19

The restoration of the painted peacocks flanking the entrance arch (second phase) were completed. Only a few fragments of third-phase white wash survive on them with the geometric designs already described in the previous report (Figures 18 and 19).

The two birds are depicted on an imitation gold background painted with yellow jarosite (originally using the encaustic technique), surrounded by plants and flowers also painted using the wax technique and now only partially preserved.

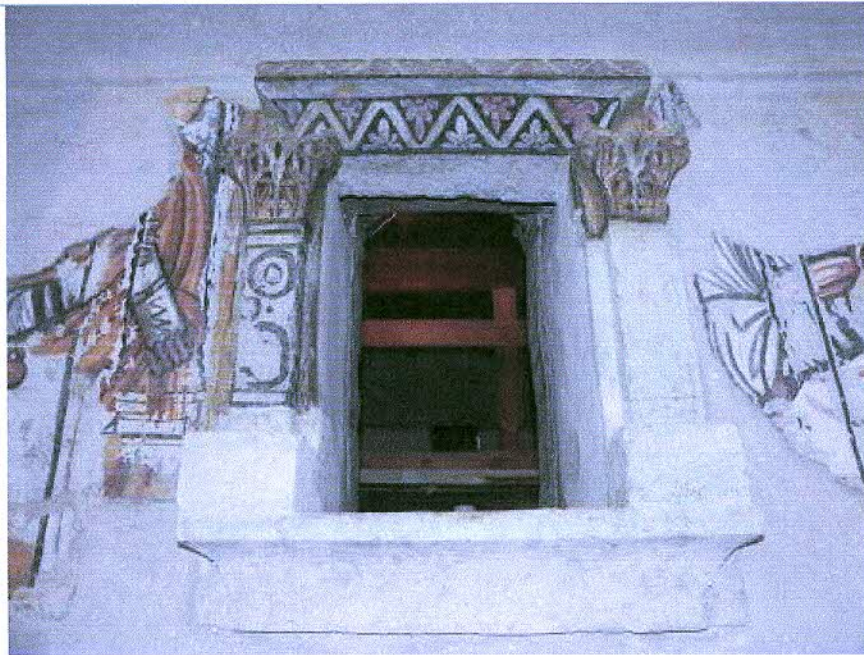
Figure 20

On the same wall, the small central window with geometric designs on the left semi-column and floral motifs on the architrave has been cleaned. Both paintings date from the second phase and only the second shows signs of partial modification during the third phase (Figure 20).

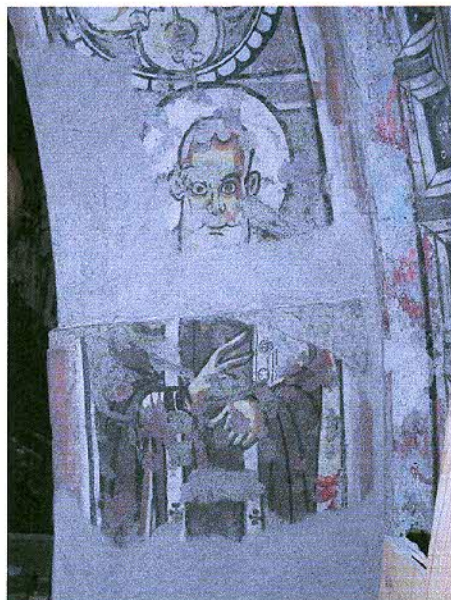
Figure 21

On the outside of the arch opposite (east triumphal arch) a sizeable section of dirt was removed from the lower right-hand side, revealing the figure of a third-phase saint painted over the circular motifs belonging to the second phase. Sadly, the extremely patchy nature of the painting prevented us from finding an inscription and consequently the identity of the saint remains a mystery (Figure 21).
